Retrofit Model X Pinch Sensor Carrier and Bump Stop

Classification Repair Bulletin **Section/Group** 11 - Closures **Country/Region** All

Year 2015-2017 **Model** Model X **Version** All

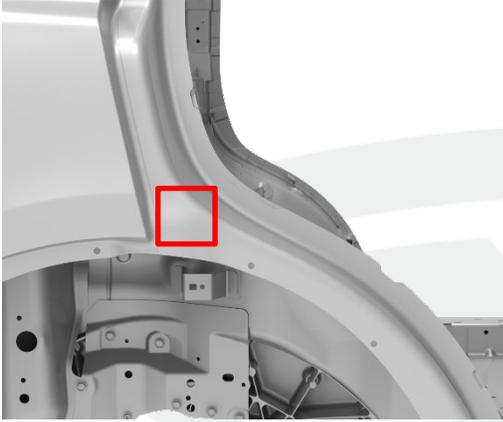
Figure 1 (Affected area)

1. Inspect the exterior jamb of both rear doors for paint damage (Figures 1 and 2).

2. Repair the damaged paint in the affected area (Figure 1):

- a. Clean and polish the affected area.
- b. Repaint the damaged area using industry standard methods and touch up paint.
- c. Make sure that the paint is dry before continuing to the next step.
- d. If necessary, sand the repainted area.
- e. Polish the repainted area.

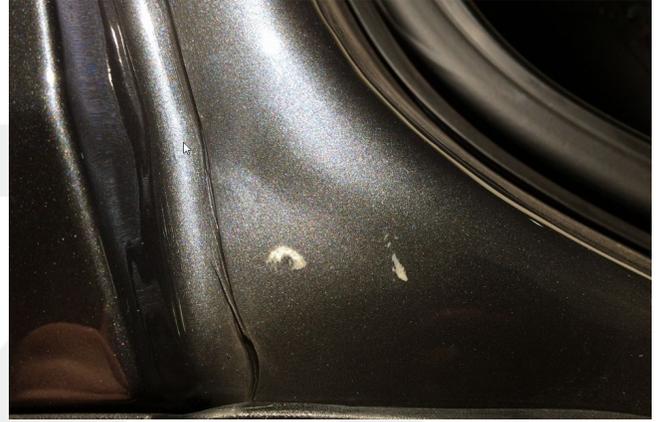
Figure 2 (Paint damage)

On some Model X vehicles, the pinch sensor carrier and/or bump stop might scratch the paint in the interior jamb on the rear (Falcon Wing) door.

- If the paint is not damaged, go to step 3.
- If the paint is damaged (Figure 2), continue to the next step.
