Updates to Increase Top Speed

Classification	Repair Bulletin	Section/Group	40 - Rear Drive Unit	Country/Region	All
Year	2014-2015	Model	Model S	Version	85, P85D

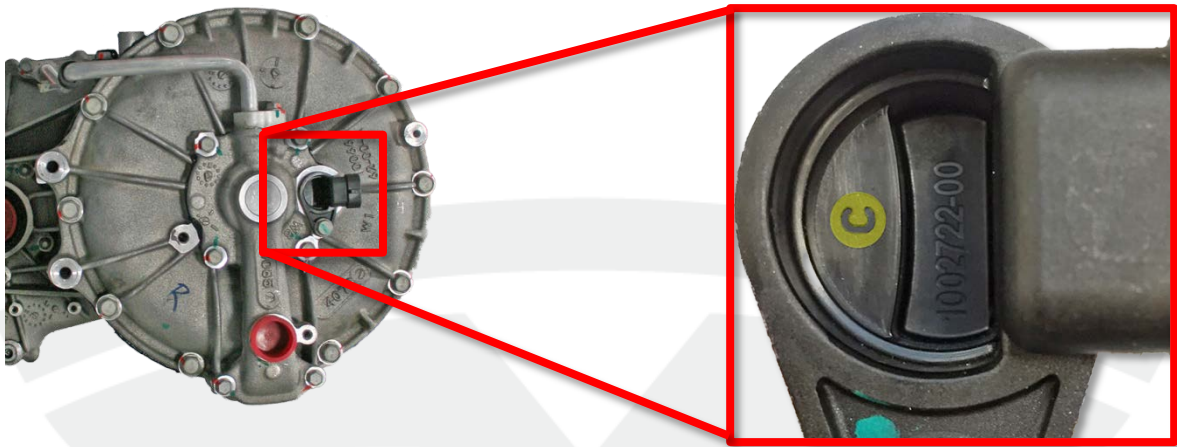
2. Use a mirror or borescope to check the part number on the rear drive unit motor speed sensor (Figure 1).
 - If the part number is 1002722-00-B, replace the speed sensor with revision C or later (refer to Service Manual procedure 40102002), then continue to step 3.
 - If the part number is 1002722-00-C or later, continue to step 3.

Figure 1 (Revision level highlighted)

Upon customer complaint, check the part number of the motor speed sensor on the rear drive unit and replace the sensor, if necessary. Perform a drive unit bootloader update.
