Adjusting Hinges for Liftgate Alignment

Classification Repair Bulletin **Section/Group** 11 - Closures **Country/Region** All

Year 2012 - 2013 **Model** Model S **Version** All

On some vehicles, the liftgate cannot be aligned to the customer's satisfaction only by adjusting the striker and snubbers.

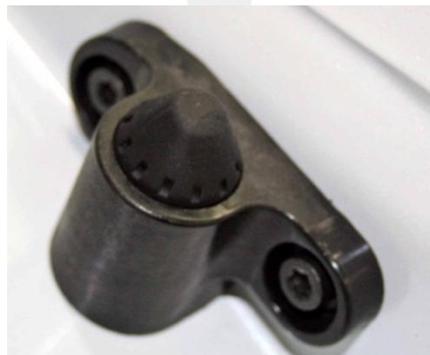
Figure 1 (RH side shown)

2. Ensure that all tires are inflated to their recommended pressures (refer to the Service Manual, General Information > Technical Data > Tire Pressures).
3. Fully close the panoramic roof, if equipped.
4. Ensure that the power liftgate is operational, if equipped.
5. Ensure that the rubber snubber on each of the quarter panels is at its lowest setting (Figure 1).

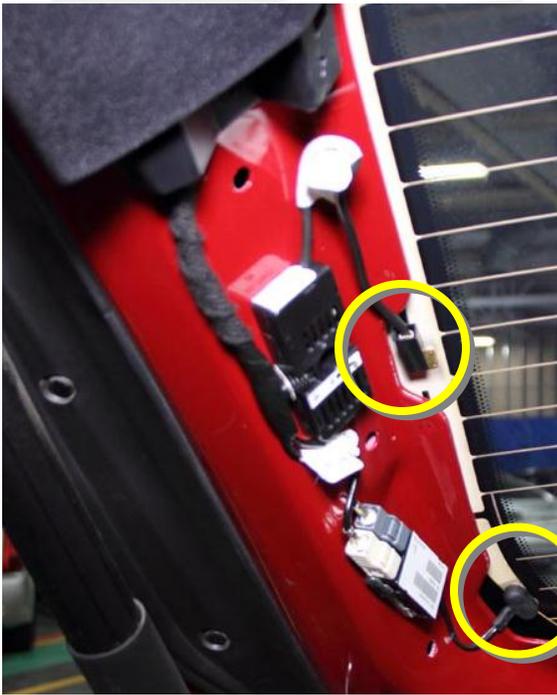
Figure 2 (LH side)

9. Disconnect the 4 harnesses that attach to the glass on both sides of the liftgate (Figures 2 and 3). Tape the harnesses to the liftgate so that they are out of the way when the glass is removed in a later step.

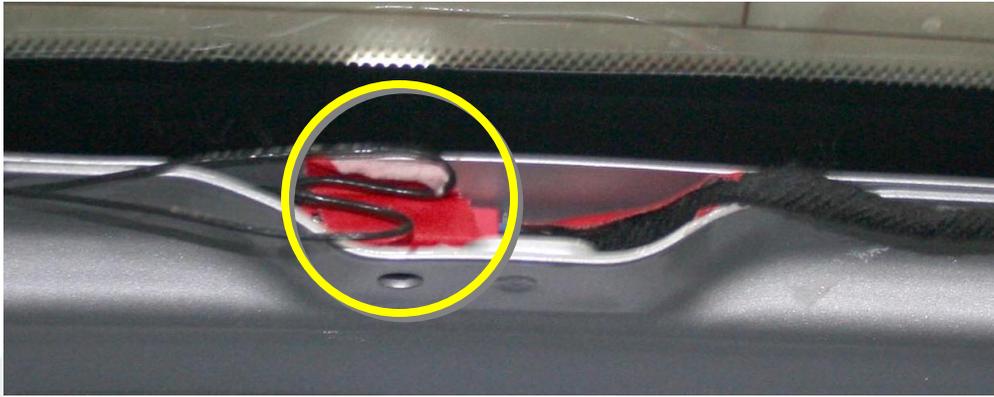
Figure 4

10. Disconnect the harness that attaches to the center high mounted stop lamp (CHMSL) (Figure 4). Tape the wires out of the way so that they are not damaged when the glass is removed in a later step.

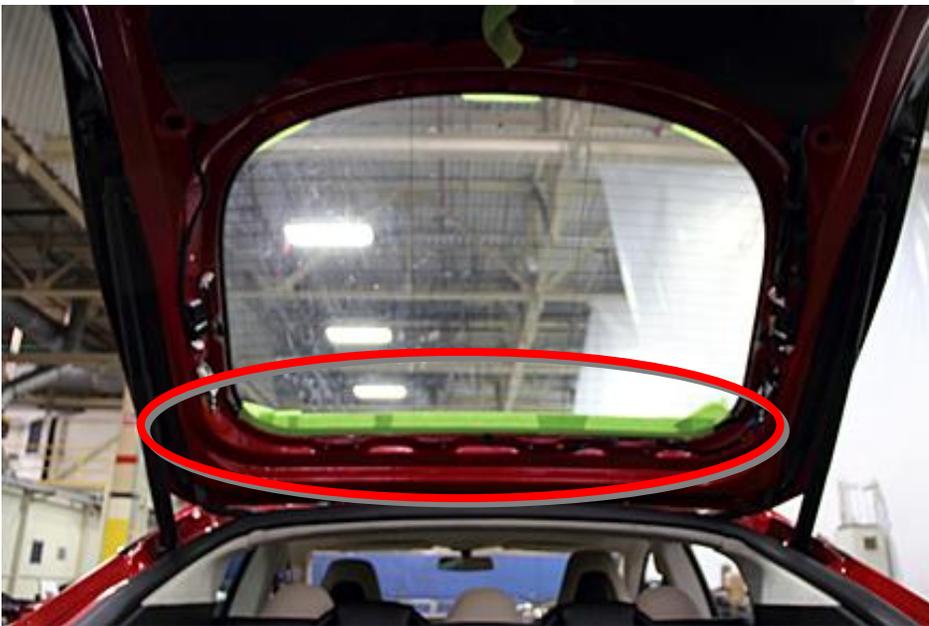
Figure 5

12. With the liftgate open, tape off the black rear frit on the liftgate glass (Figures 5 and 6).

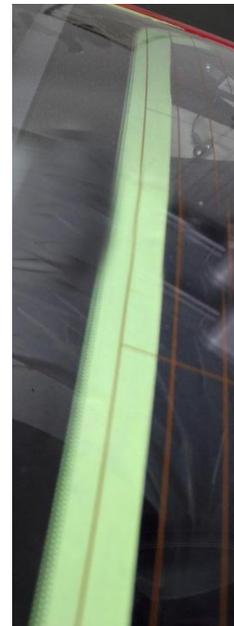
Figure 6 (View from outside of liftgate)

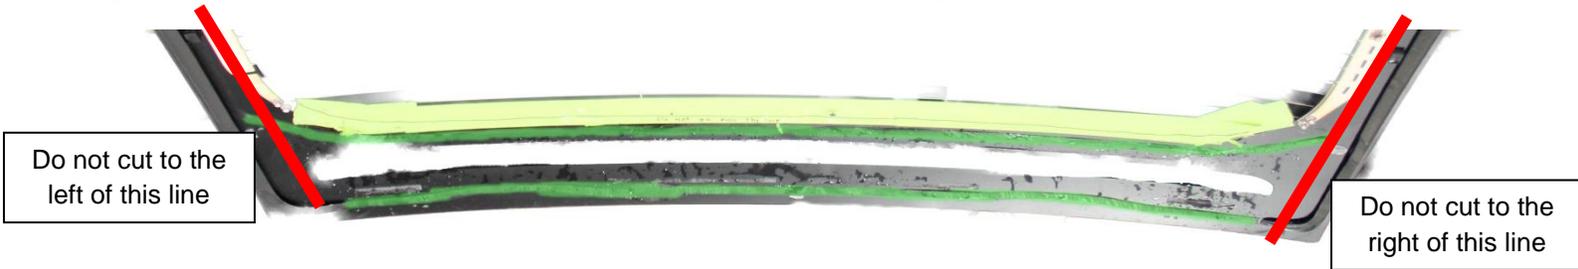
⚠ CAUTION: Only use the Equalizer Express360 to cut the 2 lines of urethane at the back of the liftgate glass (Figure 7). Do not use it to cut the urethane at the sides or bottom of the glass.

Figure 7 (Lines of urethane shown in green)

⚠ CAUTION: Do not cut past the left red lines in Figure 7.

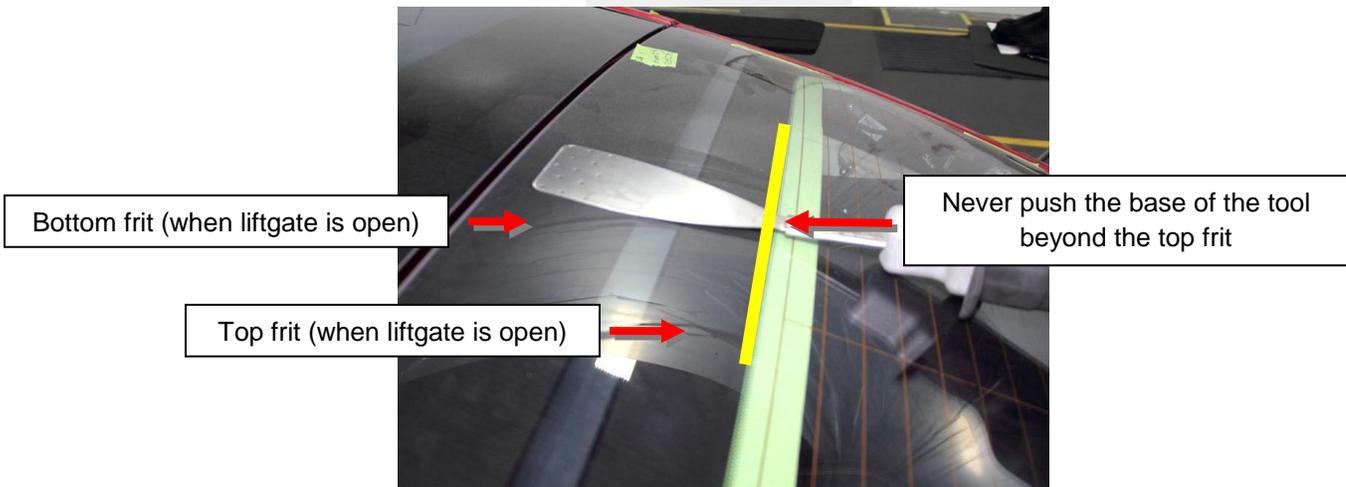
Figure 8

⚠ CAUTION: The front and rear frits protect the 2 lines of urethane from UV light. If the frits are damaged in any way, the liftgate glass must be replaced. While cutting, never move the base (non-cutting) part of the tool past the top frit (Figure 8).

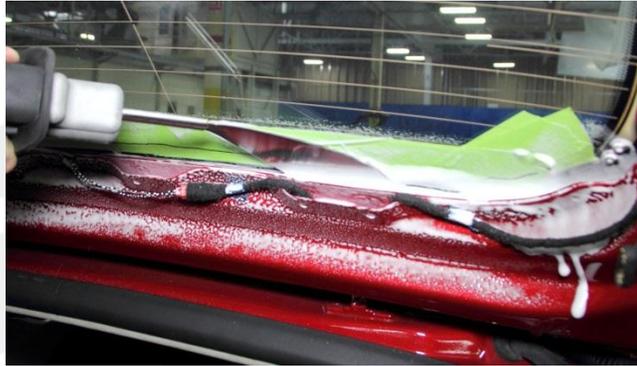
Figure 9

2. Position the tool at a 45 degree angle along the rightmost edge of the top line of urethane. Start cutting the urethane, moving the cutting tool from right to left while an assistant continues to spray the soap and water solution to lubricate the urethane (Figure 9).

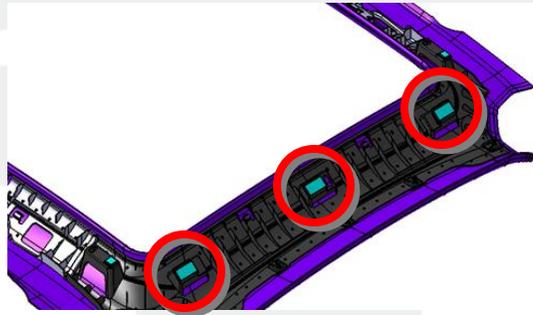
Figure 10

- It might be secured only by the trim panels.
- It might be secured with Dual lock (Figure 10).

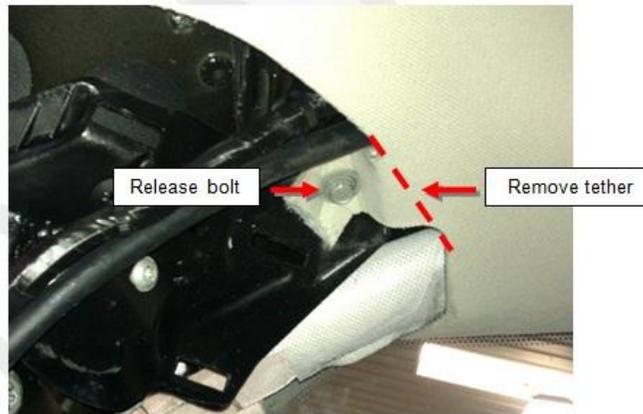
Figure 11

- It might be bolted to the body (Figure 11). In this case, cut off the tethers and discard the bolt upon reinstallation.

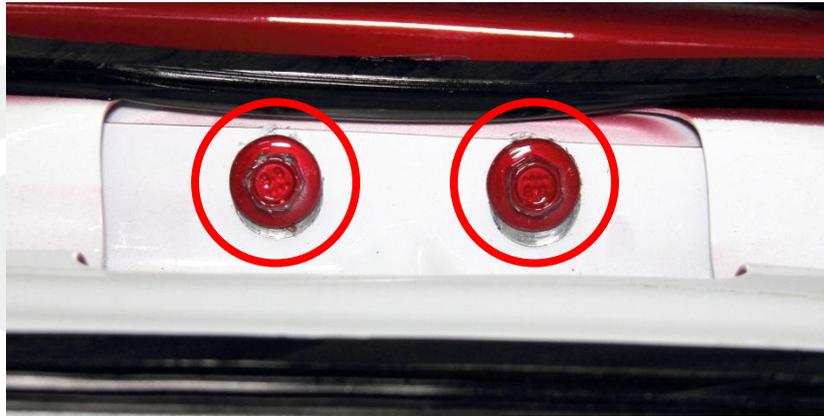
6. Remove the 2 bolts at the RH top of the liftgate (torque 10 Nm) (Figure 12).

Figure 12 (RH side shown)

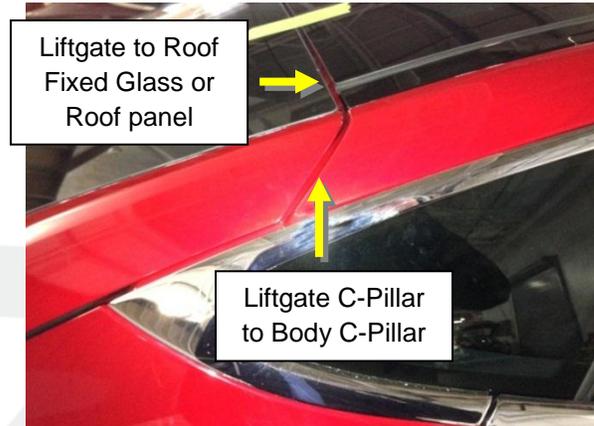
Figure 14

Liftgate C-Pillar to Body C-Pillar (Figure 14)

Gap: 5 mm +/- 1 mm
Flushness: -1 mm +/- 0.5 mm
Equal on both sides

Liftgate to Roof Fixed Glass or Roof Panel (Figure 14)

Gap: 6 mm +/- 1 mm
Flushness: -1 mm +/- 0.5 mm
Equal on both sides

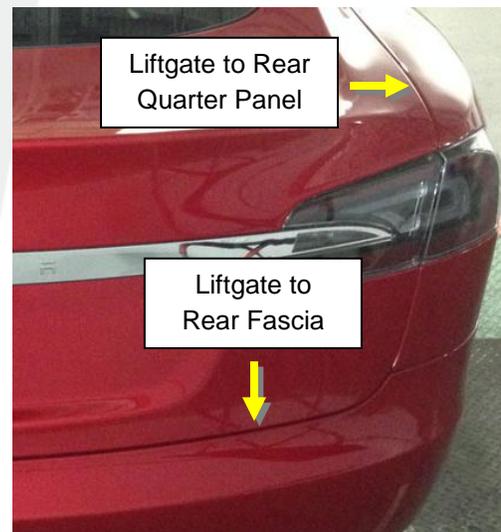
Figure 15

Liftgate to Rear Fascia (Figure 15)

Gap: 4 mm +/- 1 mm
Flushness: 2 mm +/- 1 mm
Equal on both sides

Liftgate to Quarter Panel (Figure 15)

Gap: 4 mm +/- 1 mm
Flushness: 0 mm +/- 1 mm
Equal on both sides

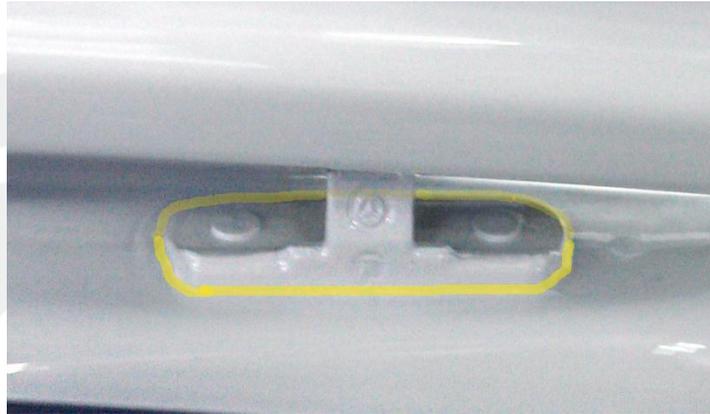
1. Once the liftgate is properly aligned, fully torque all nuts and bolts to 10 Nm.
2. Reattach the lift struts.
3. Clean and dry the area around each liftgate hinge using alcohol or a residue-free solvent.
4. Apply sealer all around the area where the liftgate hinges meet the body (Figure 16).

Figure 16 (RH side shown)

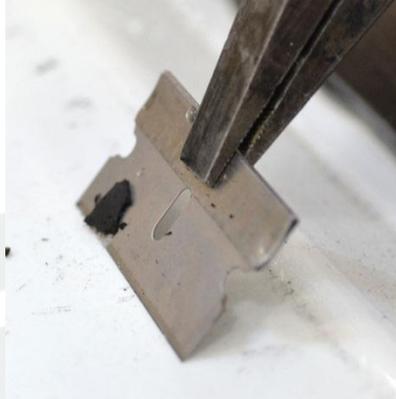
NOTE: A recommended method for this step is to grip a razor blade with a pair of pliers. Touch the blade to the body and gently push downwards. This flattens the blade, which reduces the likelihood of damaging the body (Figures 6 and 7).

✘ Incorrect
Figure 6

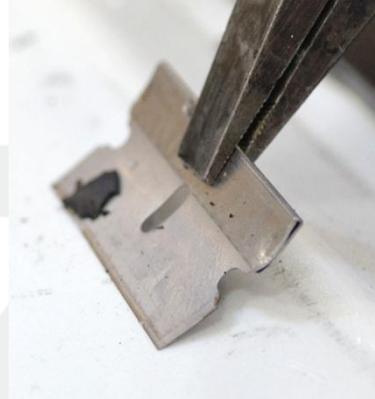
✔ Correct
Figure 7
