Cup Holder (Remove and Replace)

Correction code 15191802

FRT 0.40

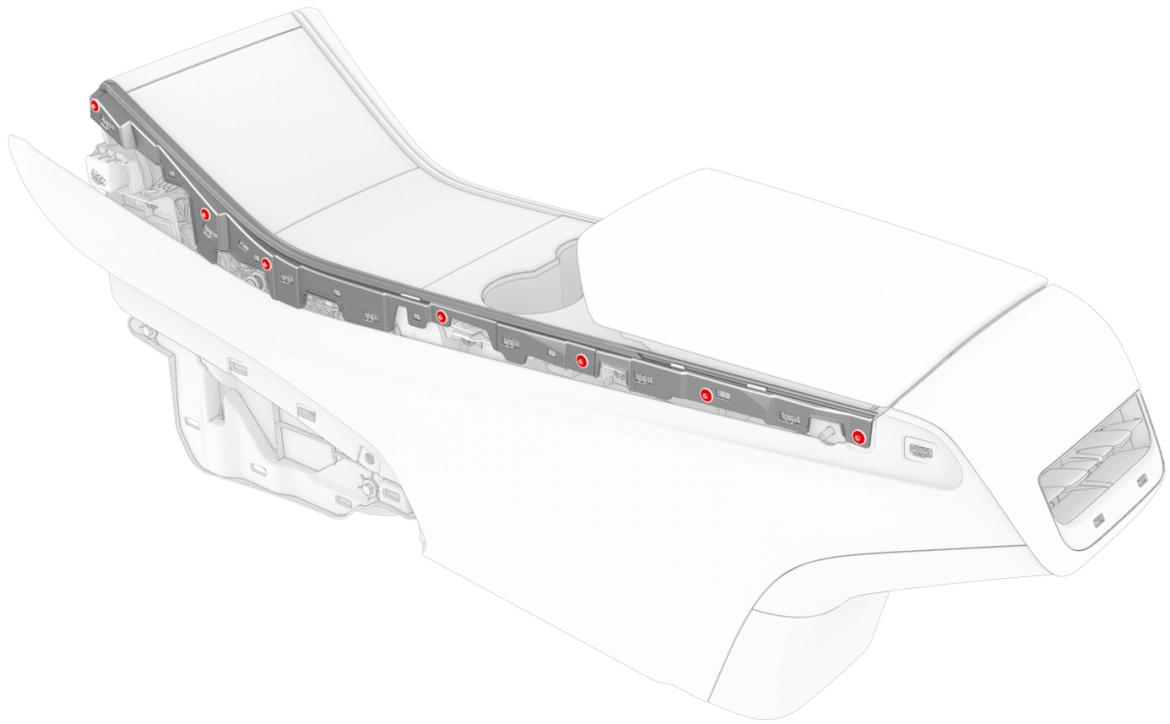
.
3. Remove the screws and release the tabs that attach LH and RH bright strips to the center console, and then remove the strips from the console.

**1.6 Nm (1.2 lbs-ft)**

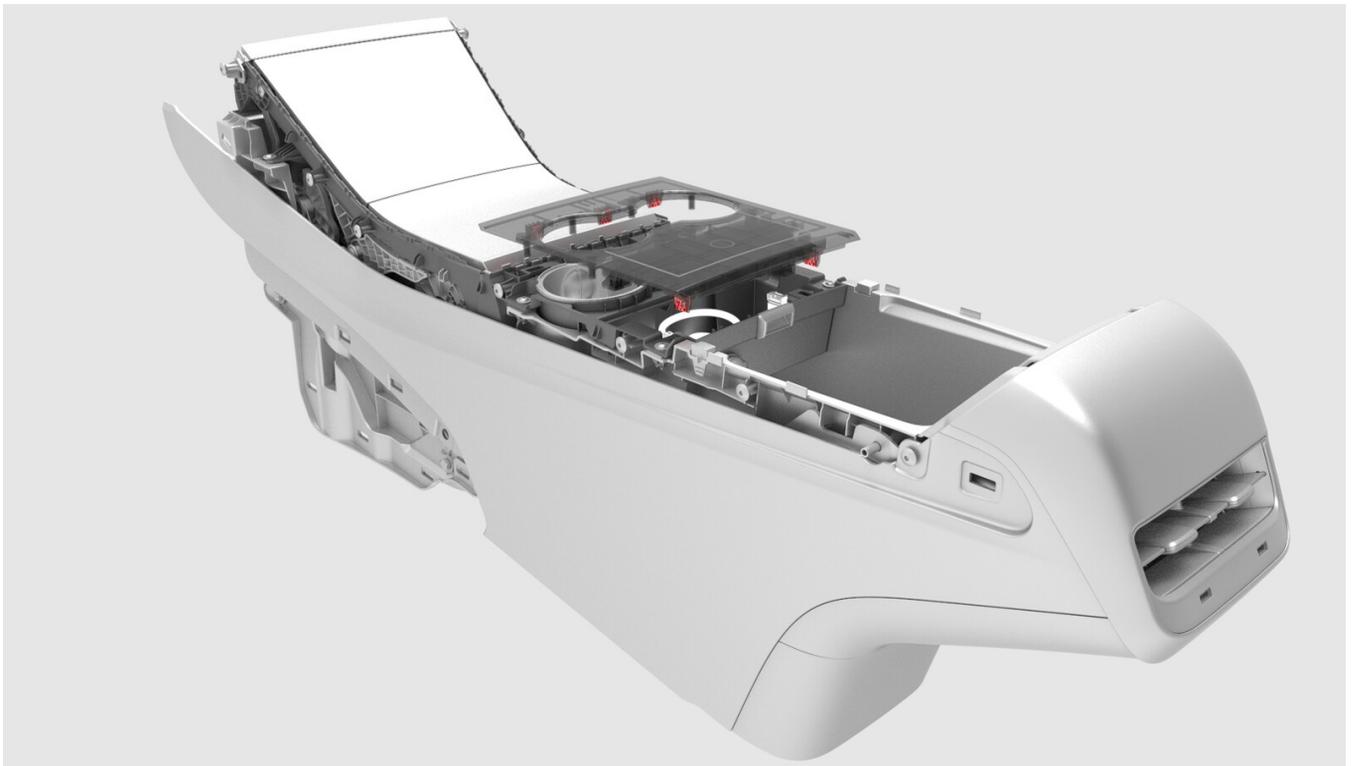
4. Open the armrest.
5. Release the clips that attach the cupholder decor trim to the cupholder assembly, and then separate the trim from the center console assembly.

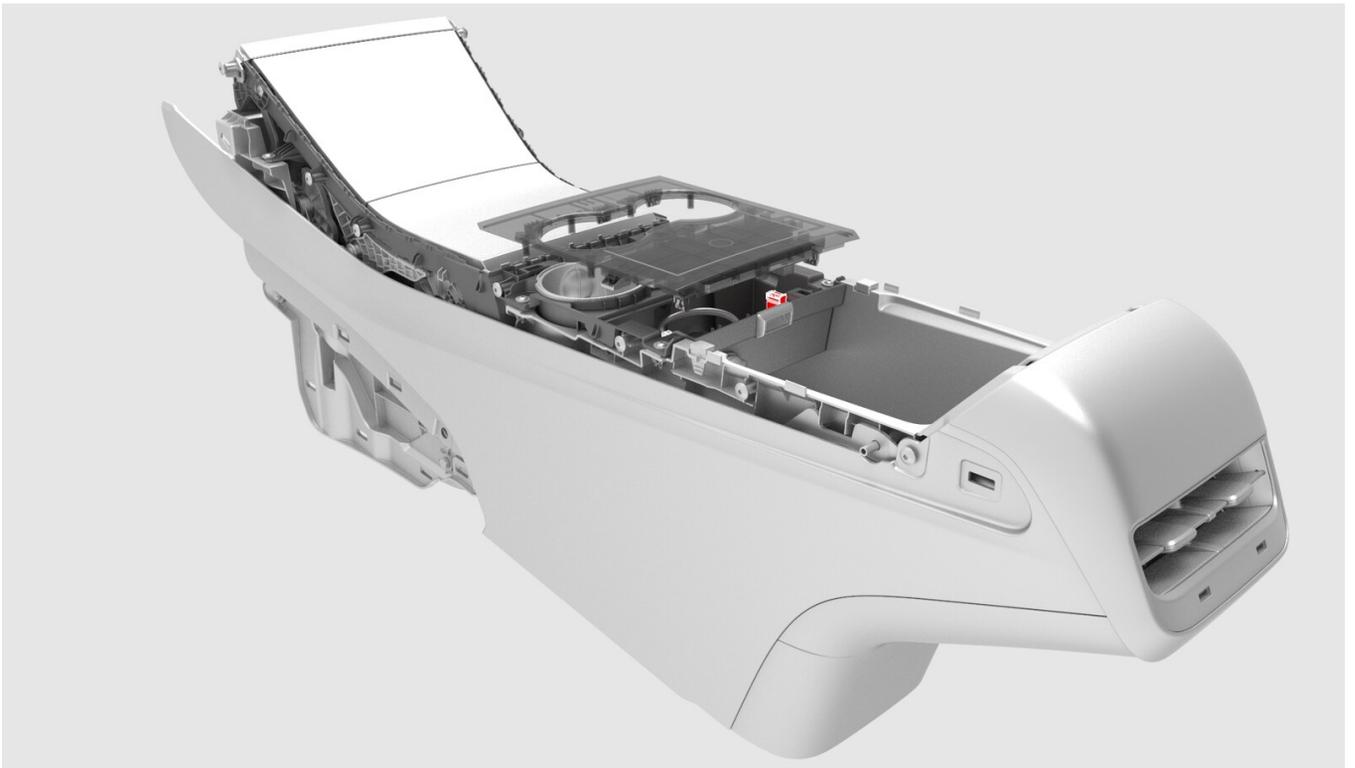
6. Disconnect the electrical harness from the security body controller module connector, and then remove the trim from the vehicle.

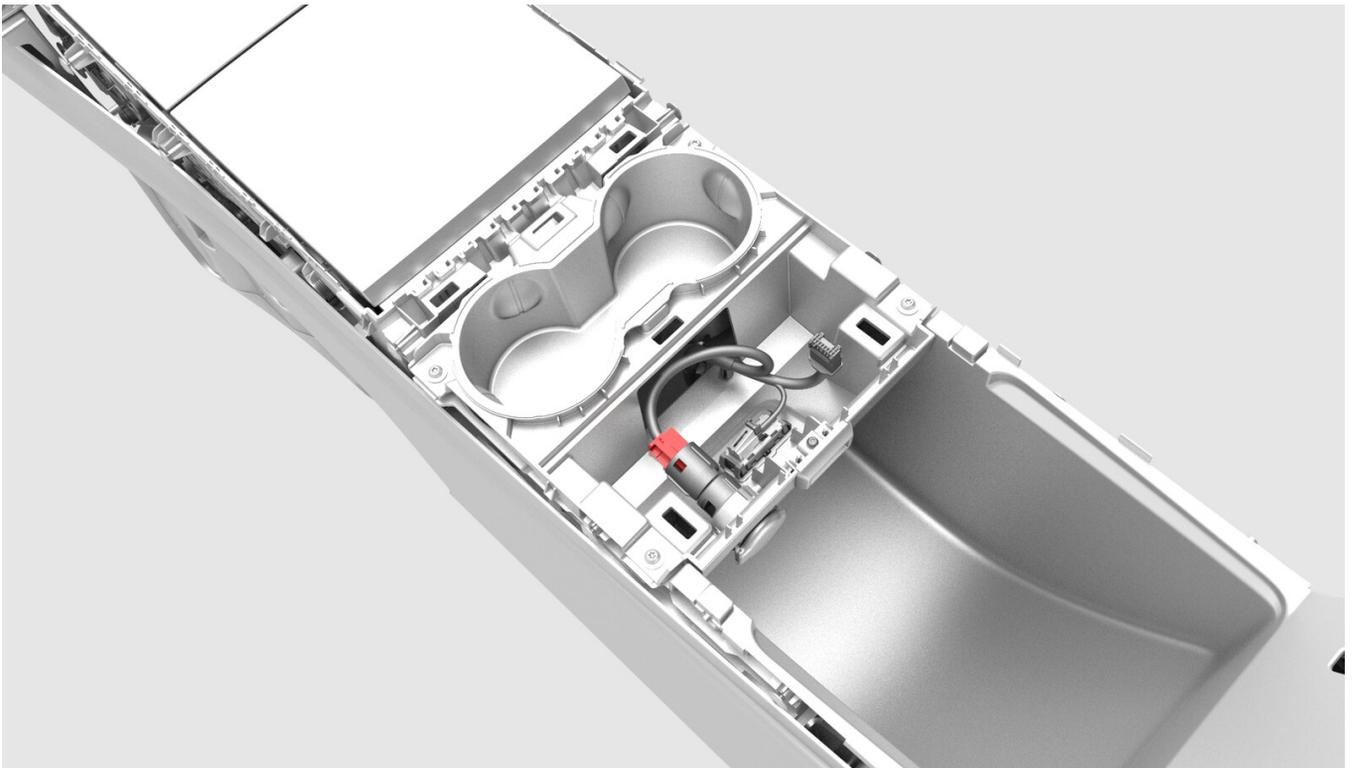
7. Disconnect the electrical harness from the center console power socket connector.

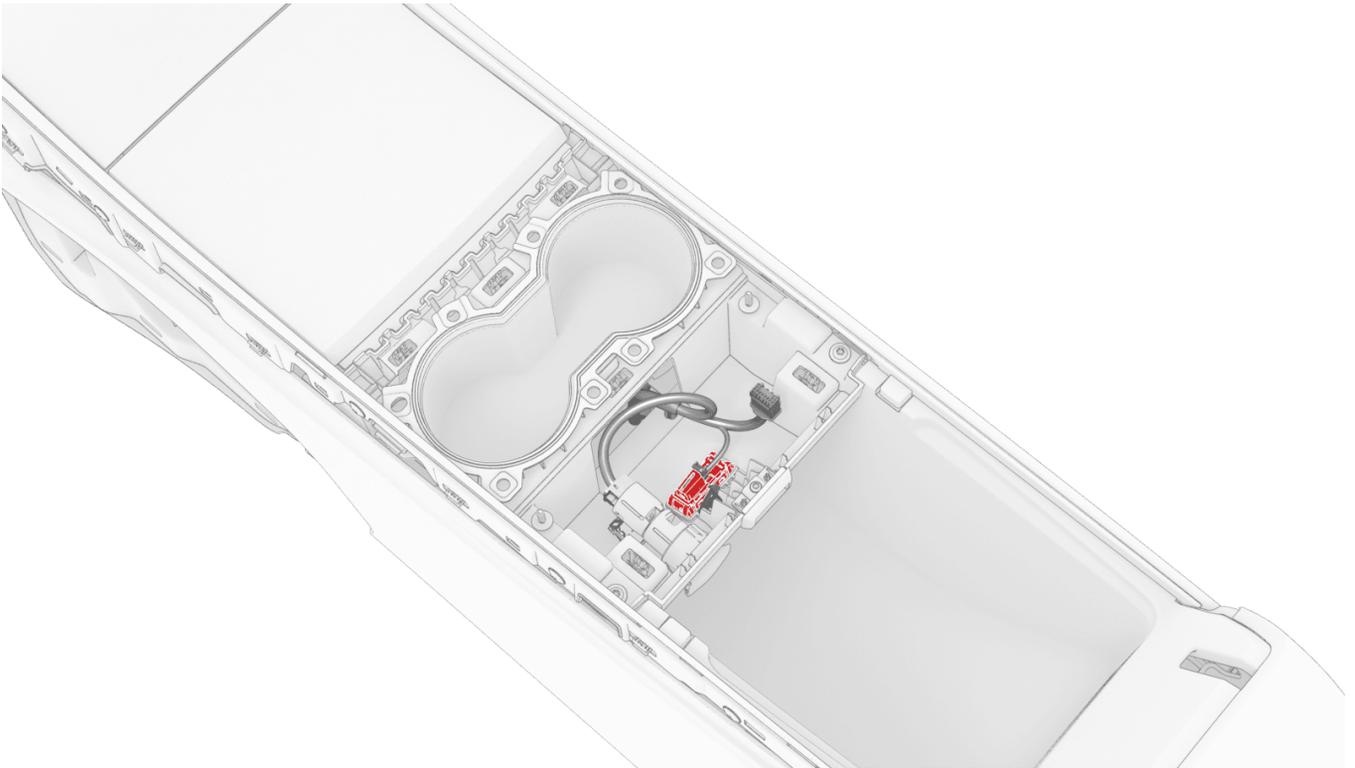
8. Disconnect the electrical harness from the center console puddle light connector.

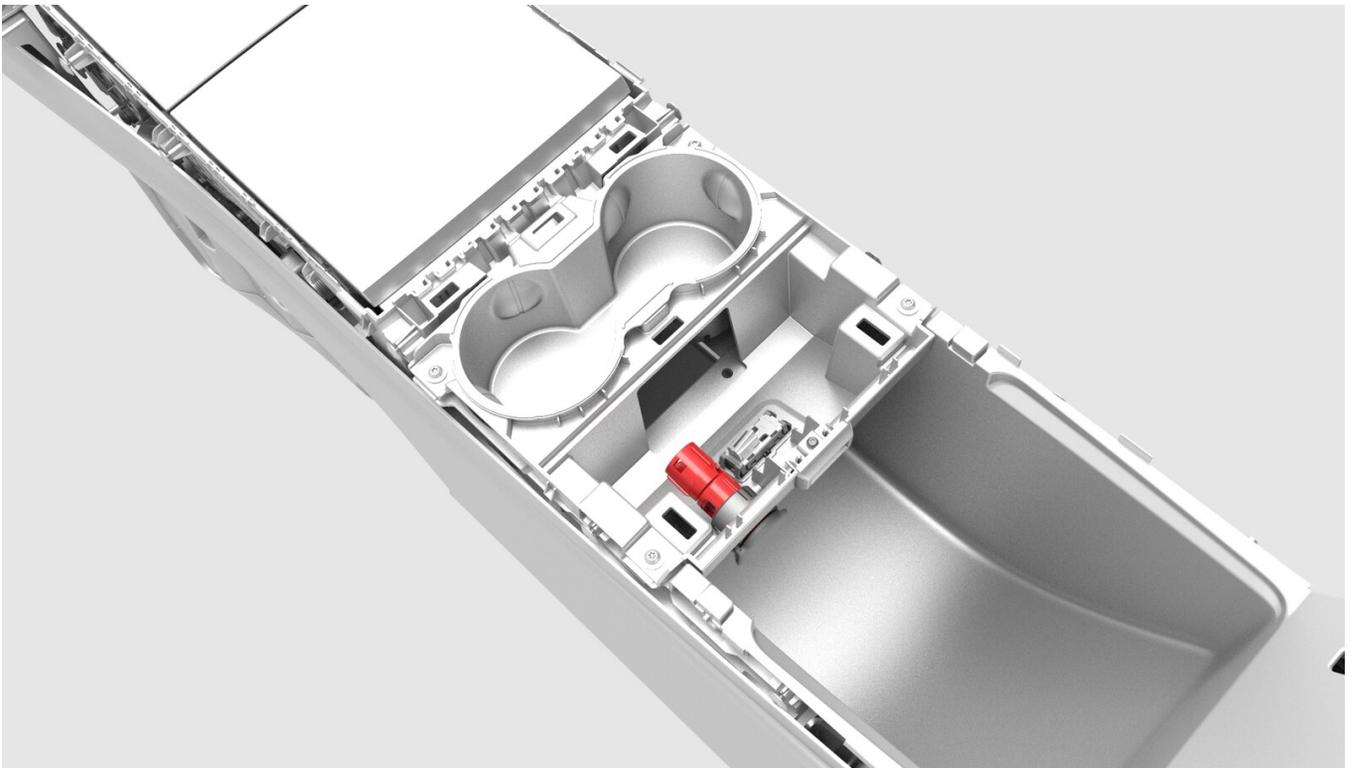
9. Release the small tabs on the spring cap and slide the power socket inside the cap, so that the openings in the side of the socket align with the large tabs of the cap.

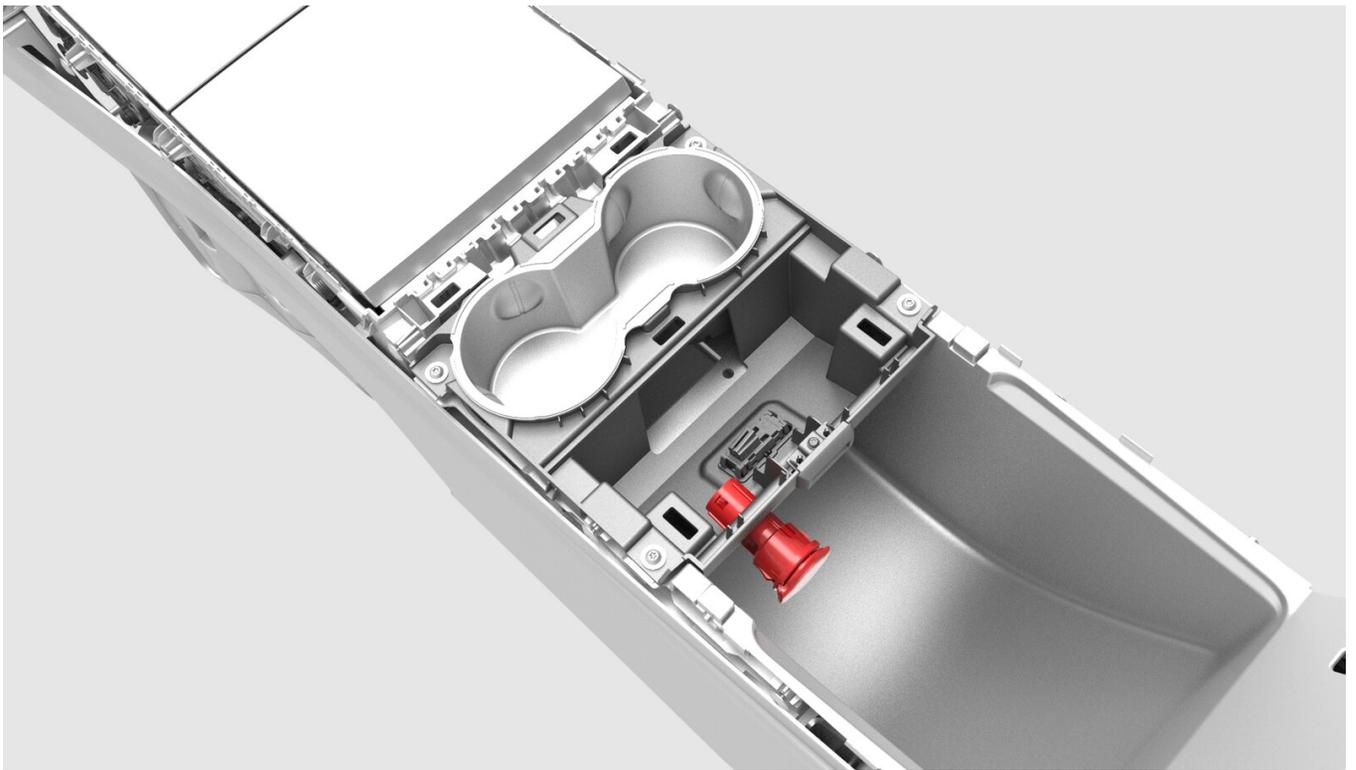
10. Release the tabs of the cap and move the power socket and cap together out through the cup holder assembly.

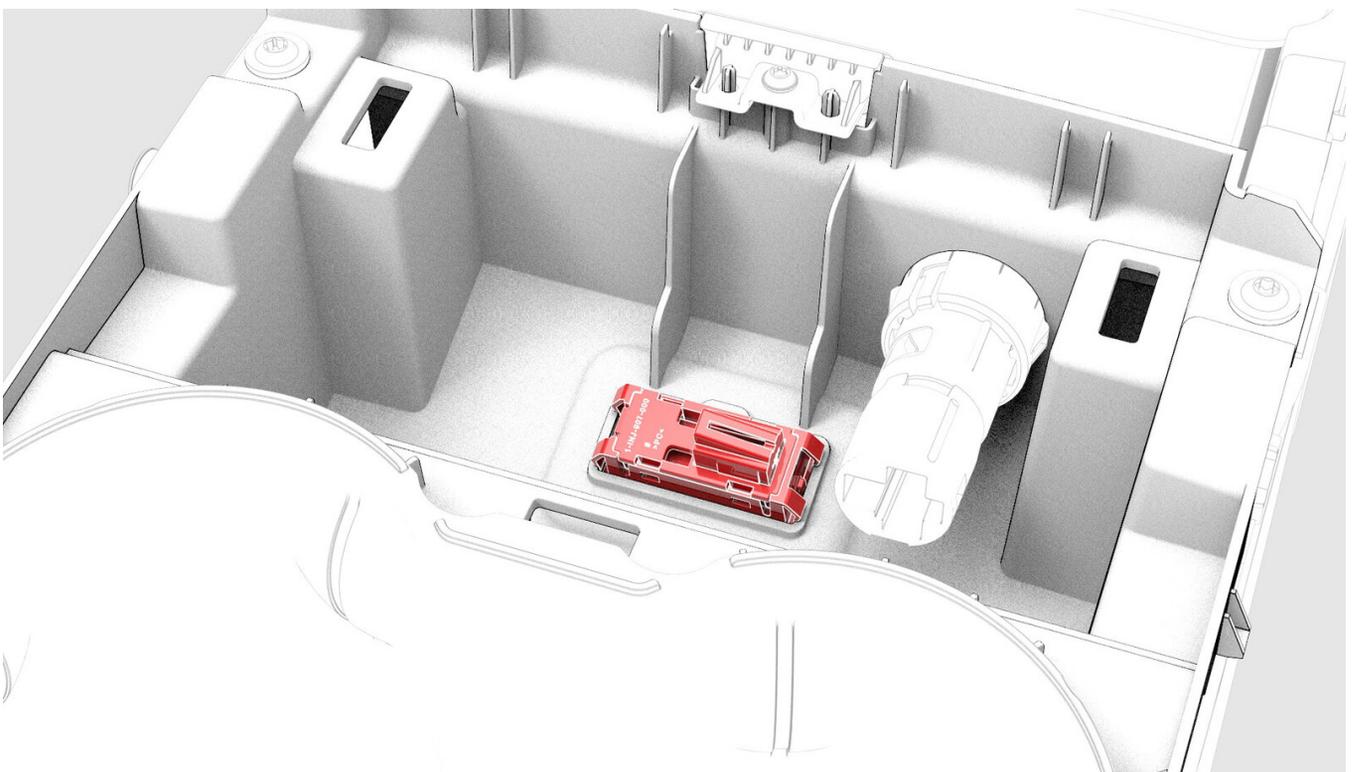
11. Release the clips that attach the puddle light to the cup holder, and then remove the puddle light from the cup holder.

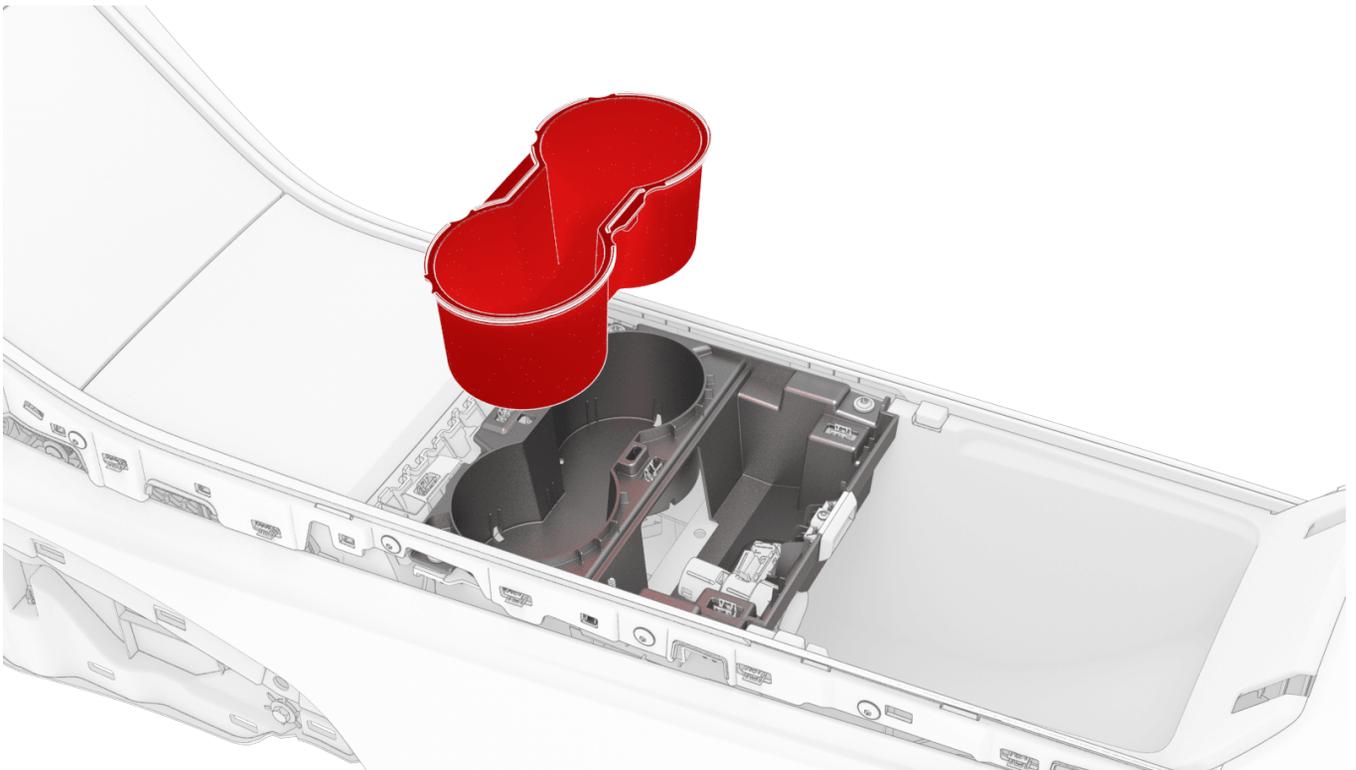
12. Use a plastic trim tool to remove the cup holder liner from the cup holder.

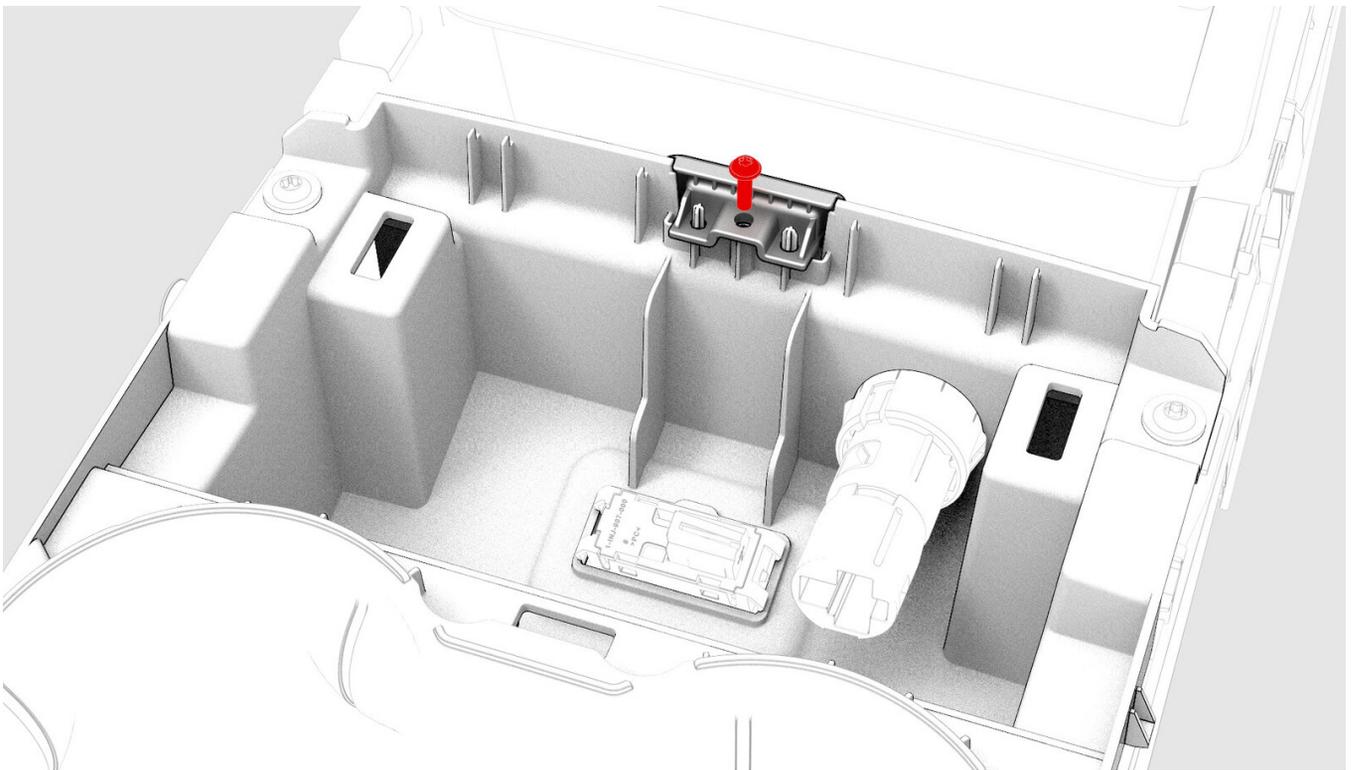
13. Remove the screw that attaches the armrest latch grommet to the cup holder.

**1.6 Nm (1.2 lbs-ft)**

1.1 Nm (.8 lbs-ft)	<ul style="list-style-type: none"> • Torx T20 socket • 4 in extension 	Reuse	
Screw that attaches the armrest latch grommet to the cup holder

1.6 Nm (1.2 lbs-ft)	<ul style="list-style-type: none"> • Torx T15 socket • 2 in extension 	Reuse

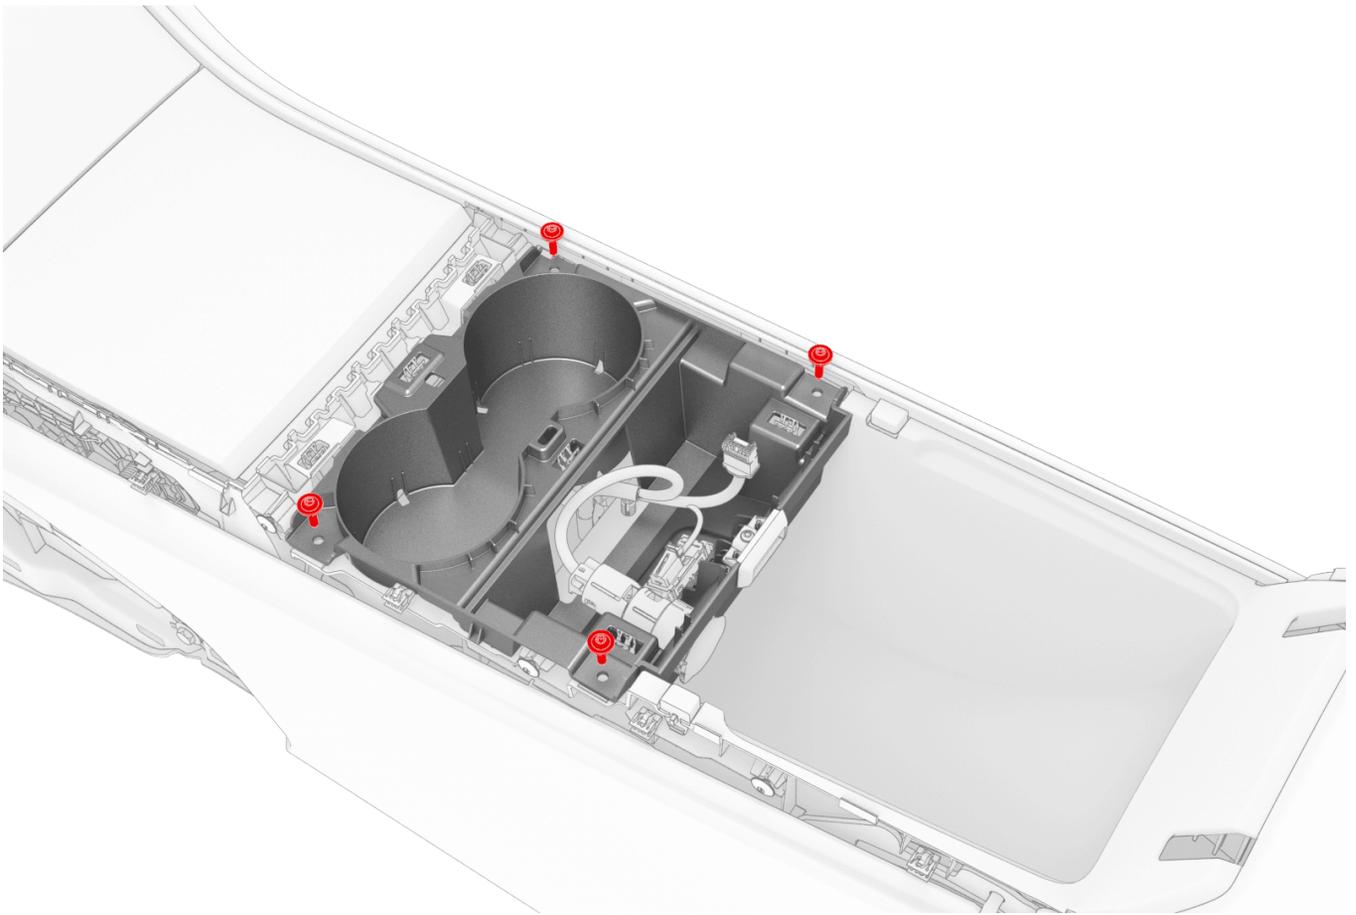
14. Remove the screws that attach the cup holder lower assembly to the center console, and remove the cup holder from the vehicle.

**1.1 Nm (.8 lbs-ft)**

Description	Torque Value	Recommended Tools	Reuse/Replace	Notes
Screws that attach the cup holder lower assembly to the center console
