# Module - TPMS - Continental (Remove and Replace)

Correction Code 34043002

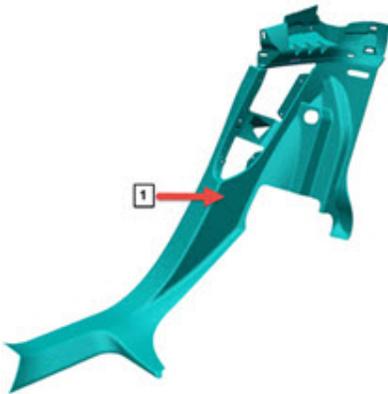
1. Remove RH rear seat bolster (refer to procedure).
2. Remove the 2nd row seat cushion (refer to procedure).
3. Release the lower section of the RH sill panel to access the TPMS ECU.

- 1 Location of TPMS ECU.

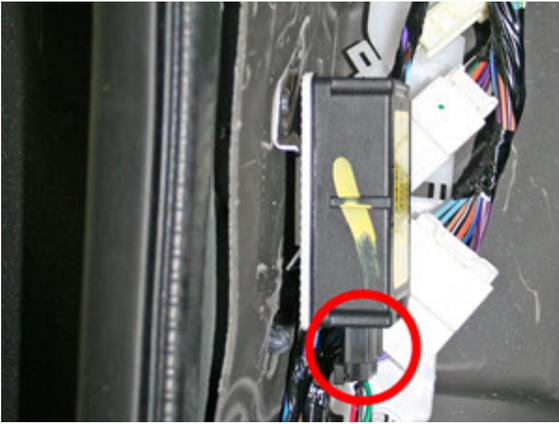
4. Release the harness from the base of the TPMS ECU.

5. Slide the ECU downwards to remove it from the metal bracket.
